AEROPRAKT SERVICE BULLETIN

№ SB A22LS-19

REPLACEMENT OF THE NOSE WHEEL FORK HINGE BRACKET OF A22LS AND A22L2 AIRCRAFT

Release date: 23.12.2019

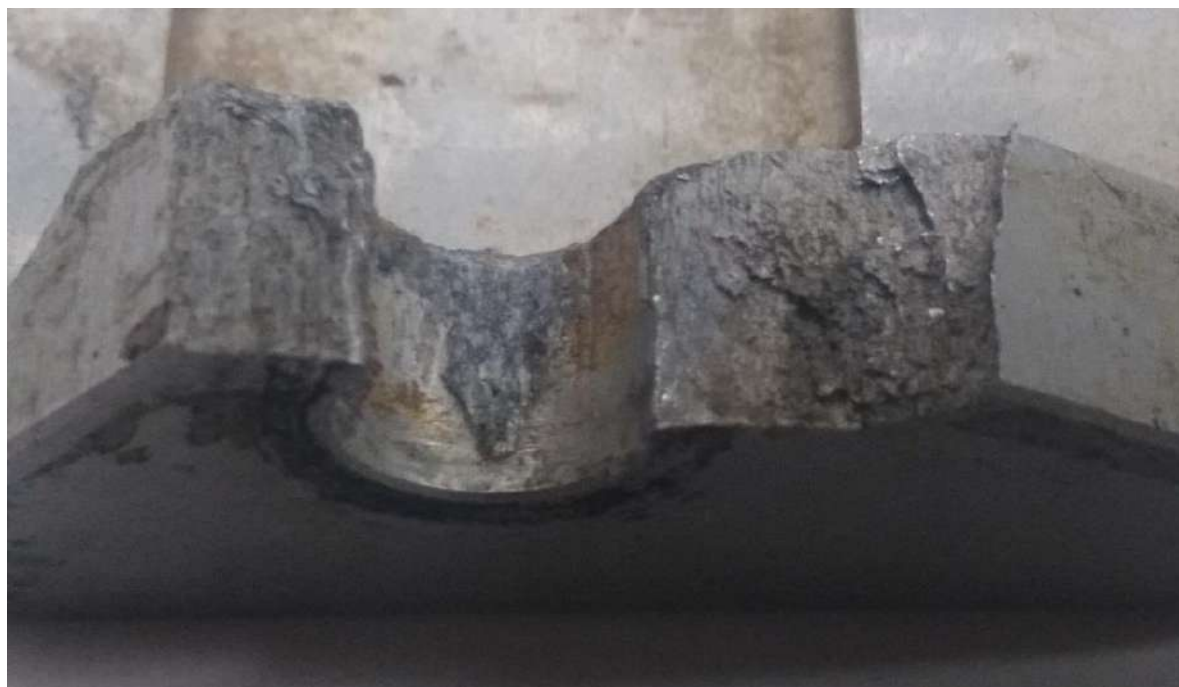
Photo 1

In conditions of high humidity and insufficient lubrication of the inner surface of the bracket hole (see photo 1) in the area of contact with the steel bolt, intergranular corrosion may appear, which affects significantly the bracket strength and may cause its disintegration.

If case if the intergranular corrosion is detected in the bracket, stop operation of the aircraft until replacement of the bracket.
