# **AEROPRAKT SERVICE BULLETIN**

## **№ SB A22LS-20**

### **CHECK OF A-22, A-22L, A-22LS AND A-22L2 AIRCRAFT HARNESS SYSTEM ELEMENTS FOR CORRECTNESS OF INSTALLATION**

**Model: A-22, A-22L, A-22LS, A-22L2**

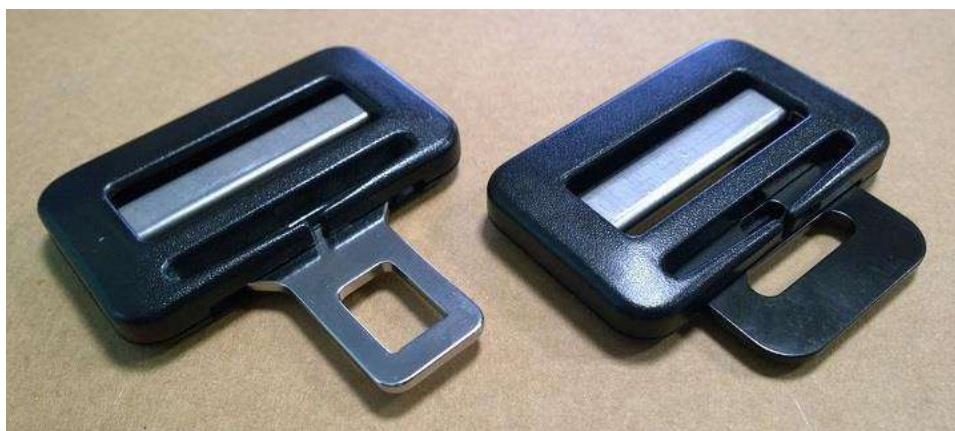
Photo 1

**Serial number(s) affected: All aircraft with harness system buckles as shown on photo 1**

Aeroprakt-22, Aeroprakt-22L, Aeroprakt-22LS and Aeroprakt-22L2 aircraft that have harness system with buckles as shown on photo 1

Incorrect placement of the buckles of the harness system.

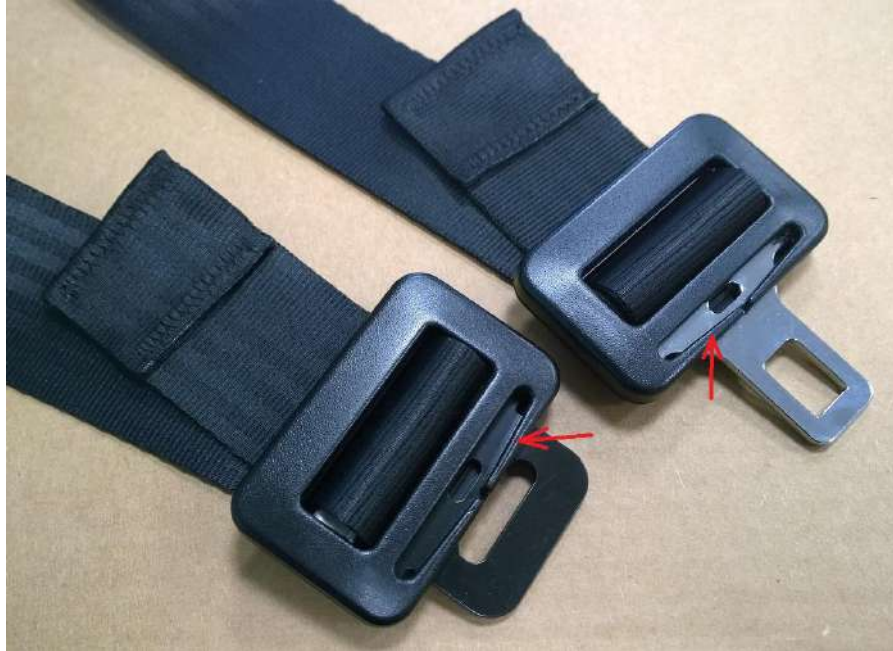
Photo 2

3.1) Check the harness belts for correct position with regard to the buckles. The correct position of the belt is shown on photo 2. Incorrect position of the belt is shown on photo 3.

▲ The specific element of the buckle marked with arrows on photo 2 must be always directed away from pilot's body when the harness system is fastened.
